**UNDERWATER FACILITIES  
INSPECTIONS  
AND  
ASSESSMENTS  
AT**

**NAVAL STATION  
MAYPORT, FLA.**

**JULY 1980**

**CHILDS ENGINEERING CORPORATION  
MEDFIELD, MASSACHUSETTS 02052**

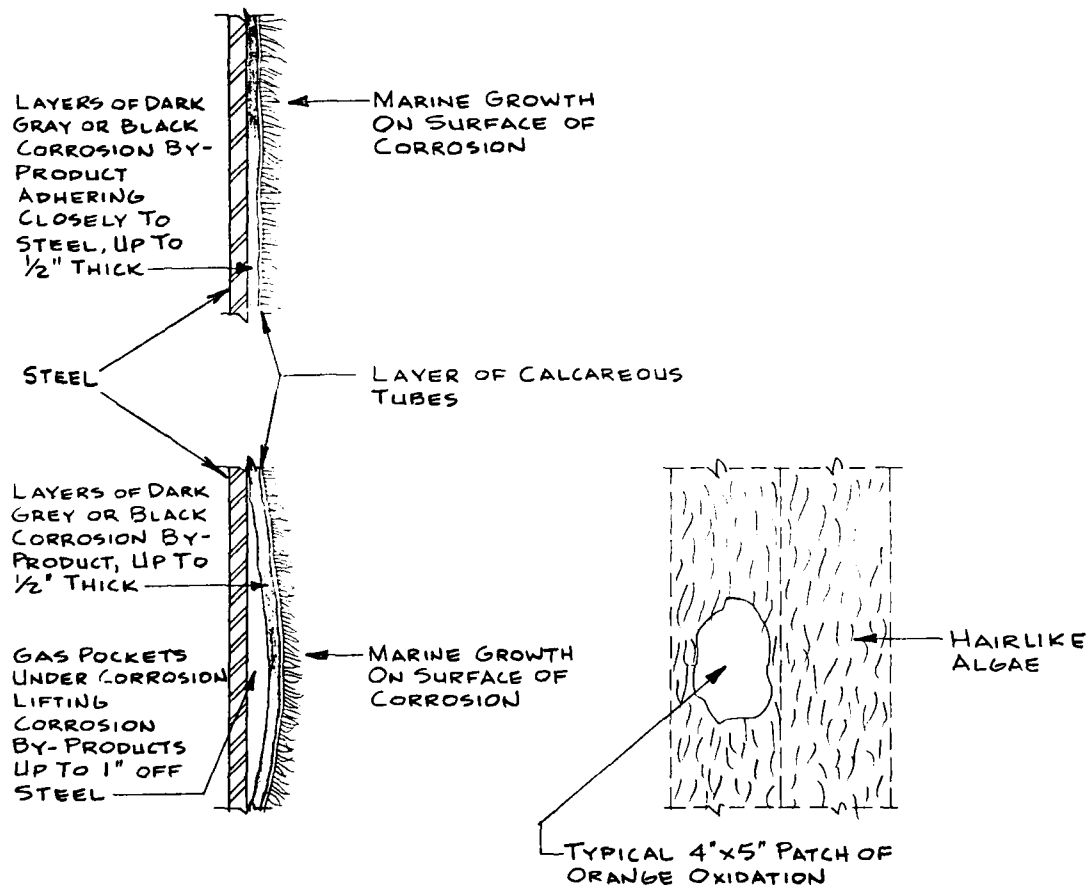
TYPICAL CORROSION BUILDUP

TYPICAL OXIDATION PATCH

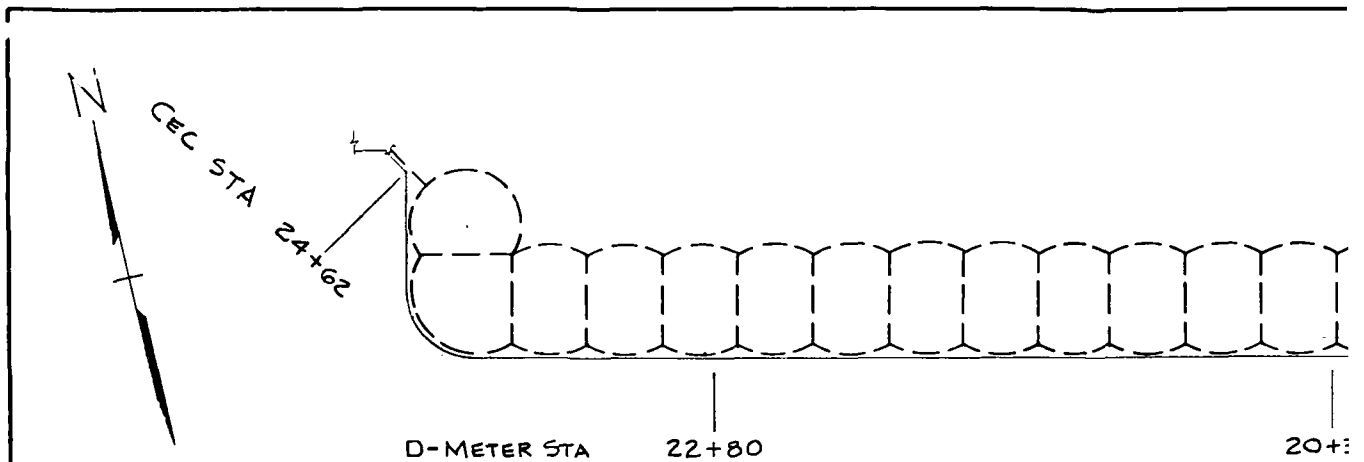
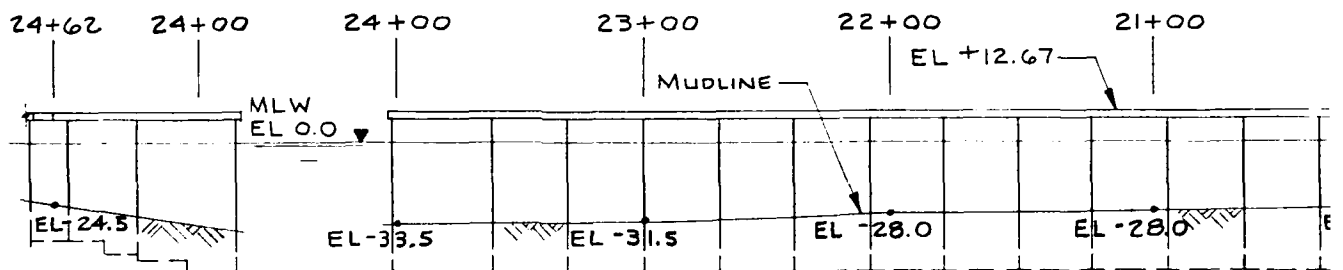
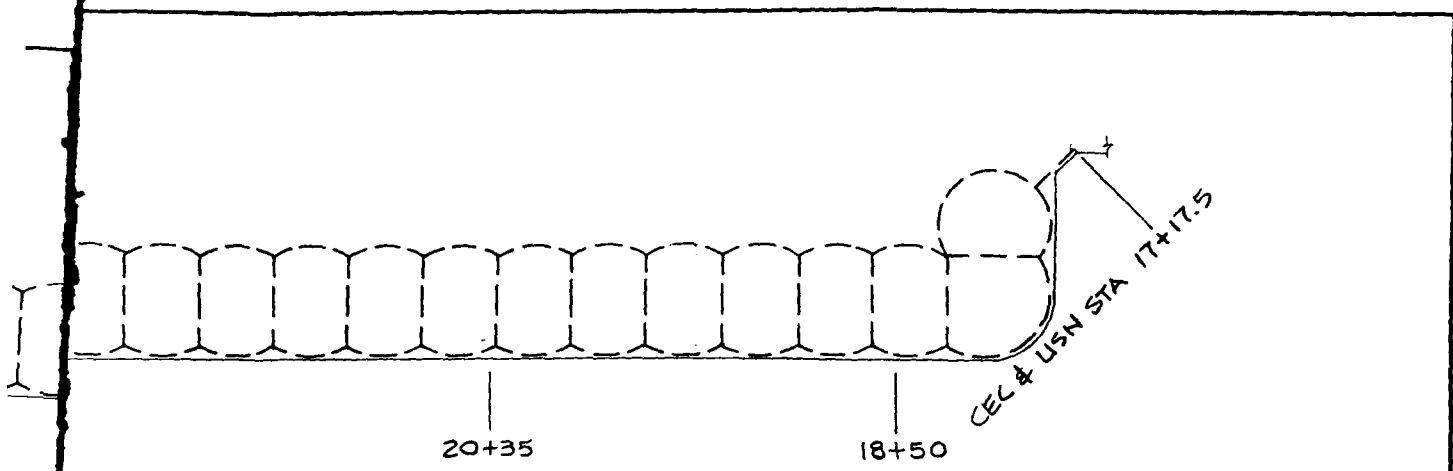
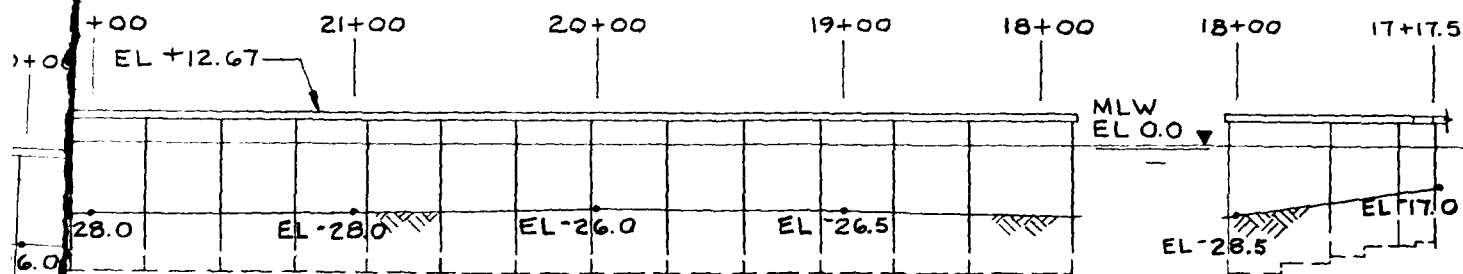
FIG. 10

Only one hole was found in the bulkhead, a 1'Ø corrosion hole, located on the outside corner cell at CEC Sta. 23+70, elevation -5.5' (see Photos #5 and #6). Further west,

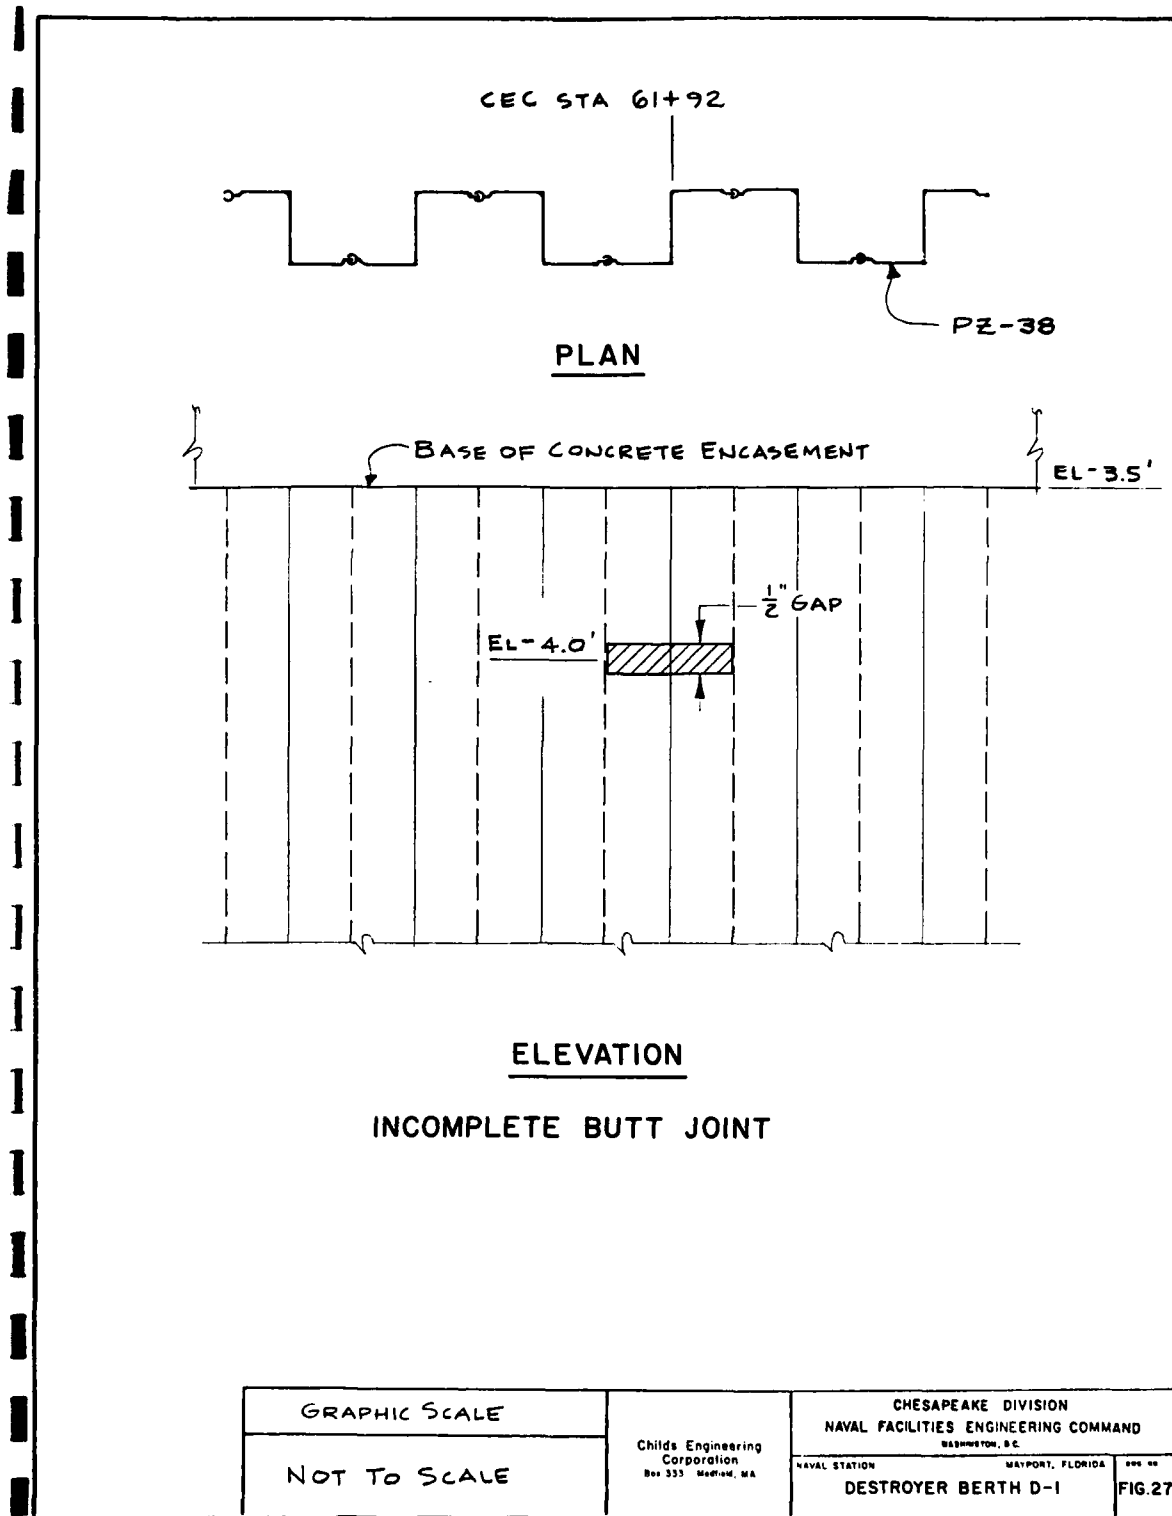
One structural anomaly was observed at D-1. At CEC Sta. 61+92, a 1/2" gap at a butt joint between two sheet piles was observed at elevation -4.0'. The tide was receding at the time and water was escaping through this gap. It appeared that the gap had been there since construction of the wall (see Figure 27).

At CEC Sta. 61+92, an unusual condition was observed at elevation -4.0'. Here a 1/2" gap existed at a butt joint between two pile sections. No evidence of recent failure was noted. Apparently, this anomaly occurred during construction and resulted from the upper pile not being driven far enough down to meet the lower pile. A joint of this type is usually made with a full penetration weld covering the full length of the joint. However, any loss of fill behind the wall would be the most critical problem resulting from this condition. The joint is not in an area of maximum stress for this type of wall (see Structural Assessment Calculations in Appendix).

It is recommended that the incomplete joint observed at CEC Sta. 61+92 (Destroyer Berth D-1) at el. -4.0' be repaired to prevent any further loss of fill and subsequent subsidence of the pavement. The cost to repair this gap with epoxy compound covering welded wire fabric is \$470.00. See Appendix for the repair cost estimate computation.

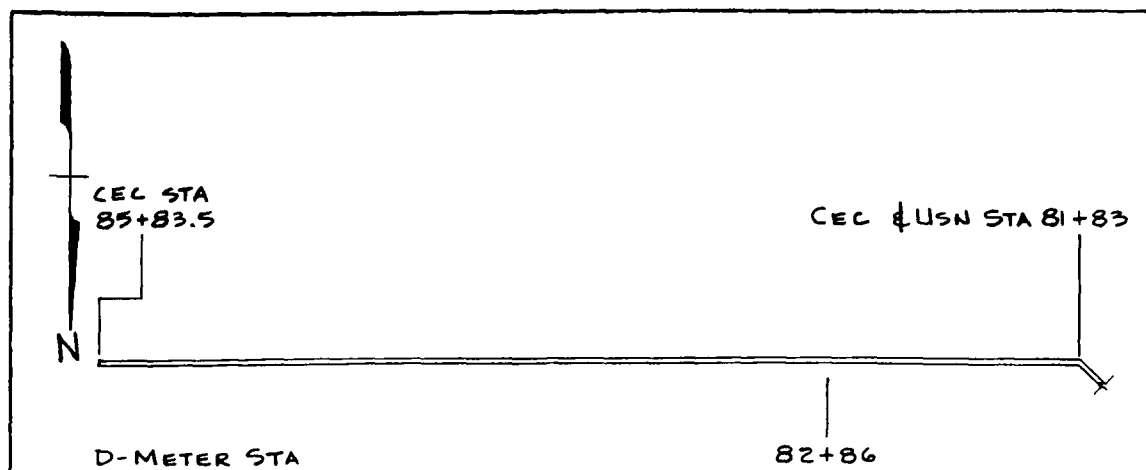
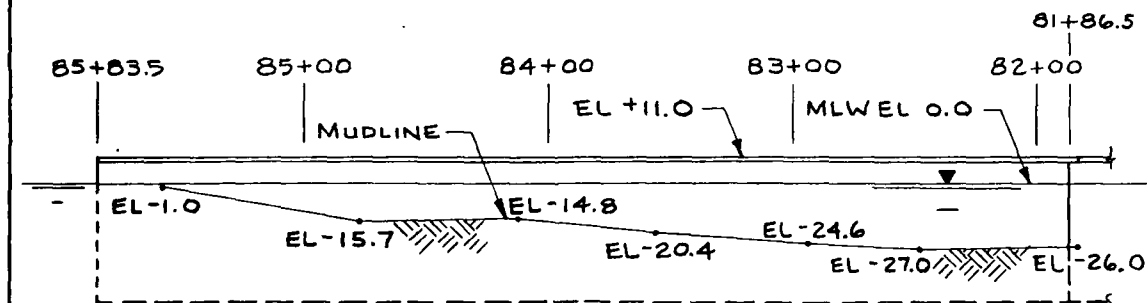
CHESAPEAKE DIVISION  
NAVAL FACILITIES ENGINEERING COMMAND  
WASHINGTON, D.C.  
NAVAL STATION MAYPORT FLORIDA  
SMALL CRAFT BERTH  
FIG. 29

The bulkhead is an anchored steel sheet pile wall, with reinforced concrete cap and curbing. From CEC Stations 81+83 to 82+83±, there is a reinforced concrete encasement that runs from below the cap to elevation -3.5'. This part of the wall was built around 1959 along with the destroyer berths. There is no encasement on the remainder of the bulkhead, which appears to have been built around 1961. The entire bulkhead is comprised of PZ-38 sections with an inside anchoring wale fastened to the wall with 1½" bolts on each inner flange at elevation -2.5'. The sheet pile sections were driven to elevation -49.0' and designed for a variable dredge depth not to exceed -30.0' at the base of the bulkhead (see Figure 29).

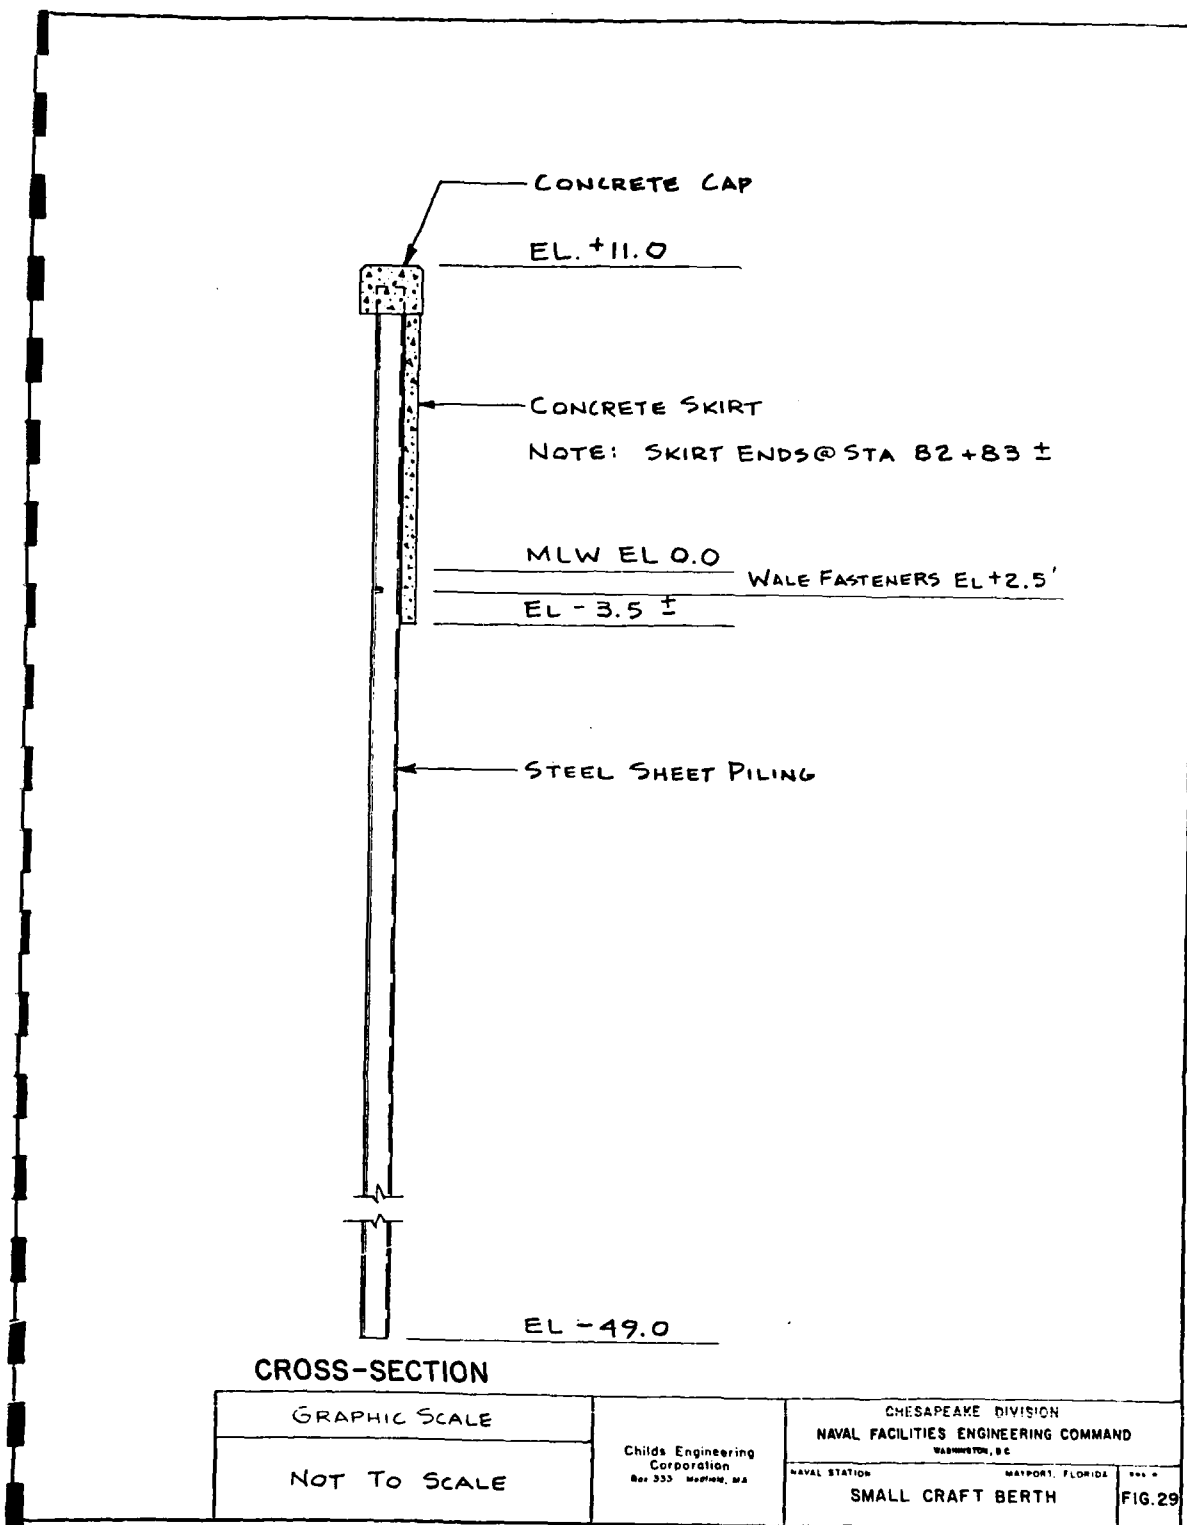
In this berthing area, the only structural damage observed occurred at CEC Sta. 82+65 at elevation -6.5'. Here a 6"Ø hole in the web was found with a piece of timber extruding from the hole. No subsidence in the pavement behind the hole was observed.

In the area where the hole was noted, loss of fill is the most critical problem that could occur since its location is not in an area of maximum stress.

To prevent the continual loss of fill and eventual subsidence of the pavement, the hole at CEC Sta. 82+65 at el. -6.5' should be patched. There are several techniques which could be employed to patch this hole and eliminate the loss of fill. The range in costs for the repairs is estimated between \$450.00 and \$500.00, depending on the repair technique employed.
